Technical Report CHL-97-17 August 1997

Periodic Inspection of Humboldt Bay Jetties, Eureka, California

Report 1 Base Conditions

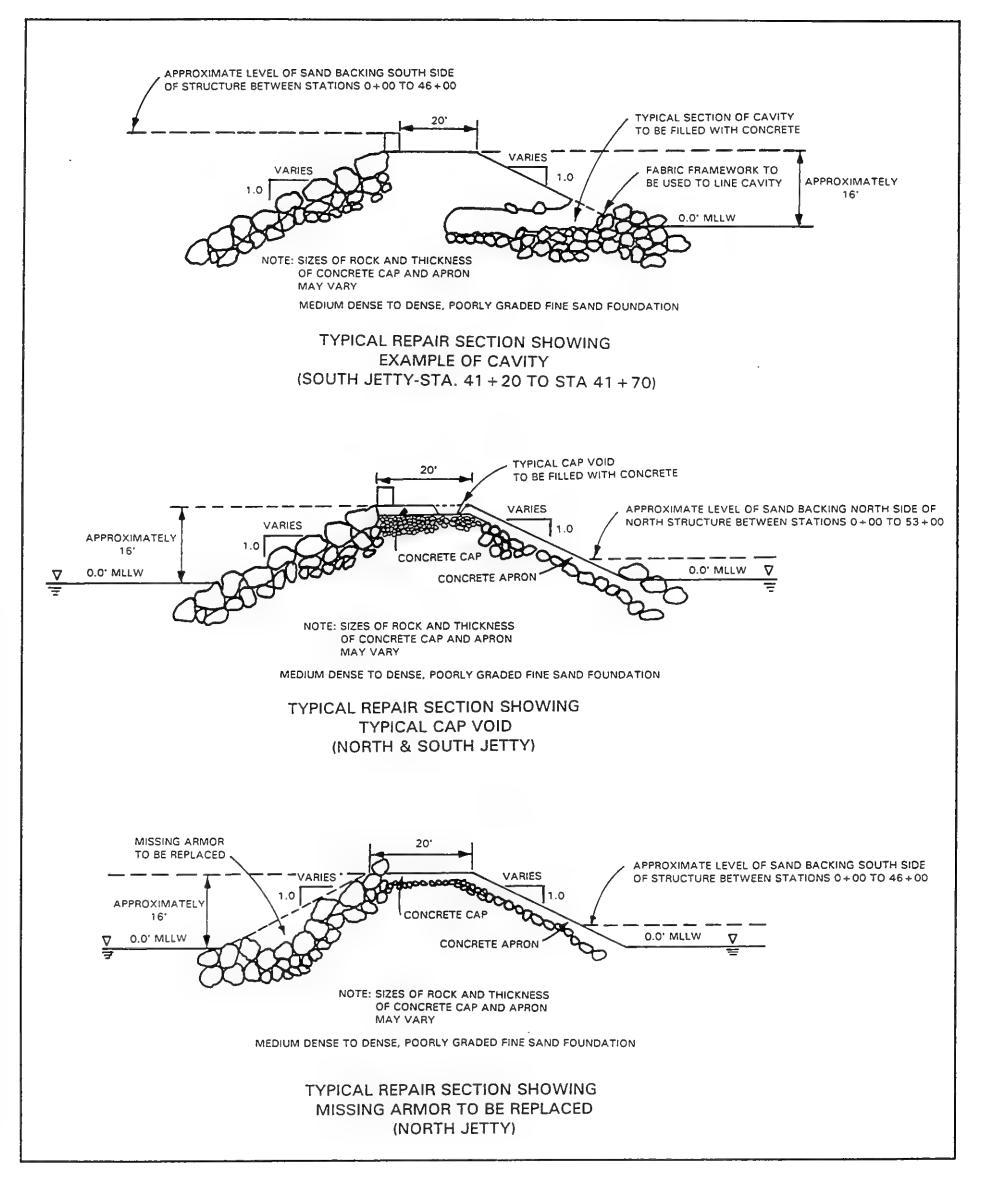
In 1988, substantial repair work was done on both of the jetties. Repairs involved the use of approximately 181,440 kg (2,000 tons) of stone for slope repair and 765 cu m (91,000 cu yd) of concrete for the filling of voids in the structure (USAED, San Francisco 1988). Figure 5 shows typical repairs made in 1988, and Figure 6 provides a plan view of Humboldt Bay, the jetty structures, and the navigation channels as of December 1994.

Figure 5. Typical repairs made to jetties in 1988

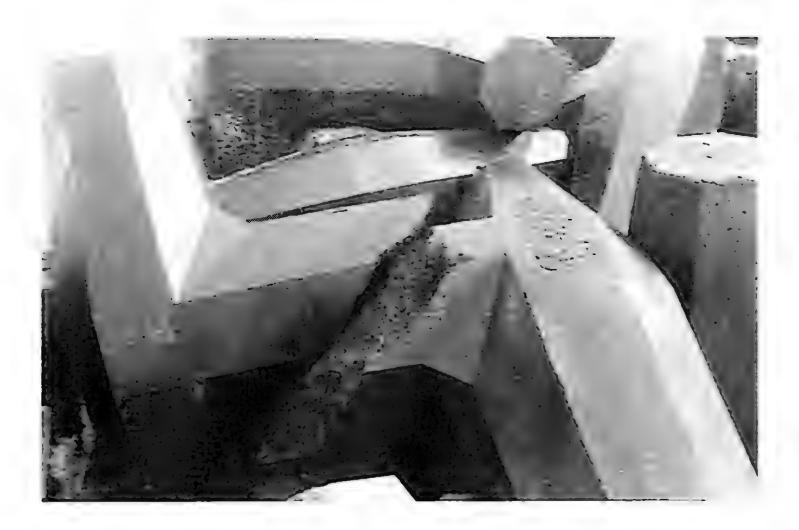
Figure 17. Dolos with angled, mid-shank break

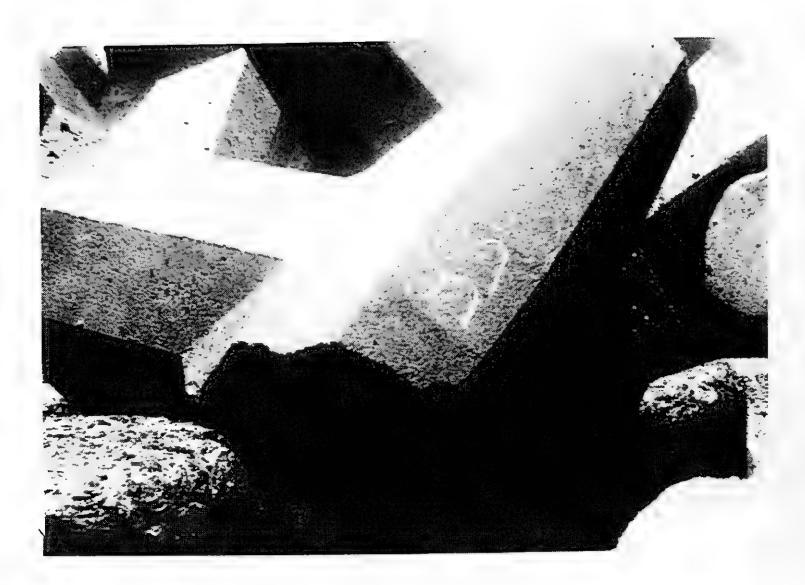
Figure 19. Dolos with straight fluke-shank break

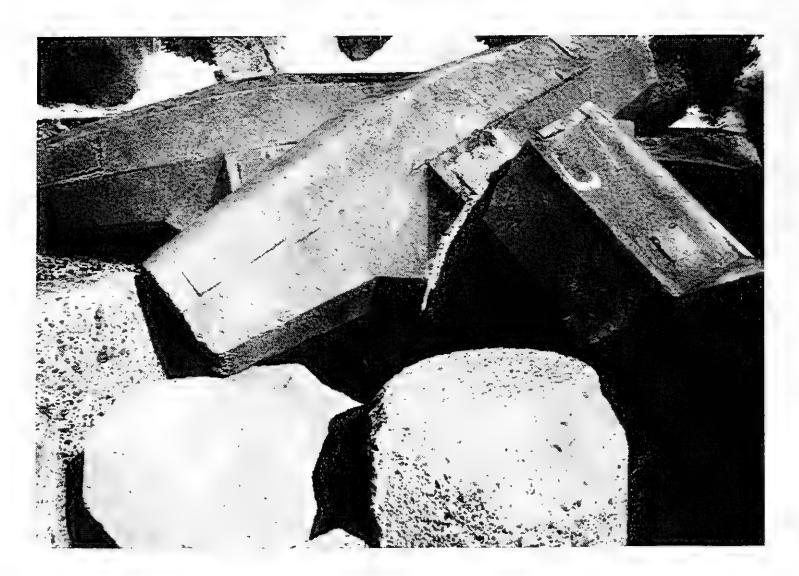
Figure 20. Dolos with straight, shank-fluke break

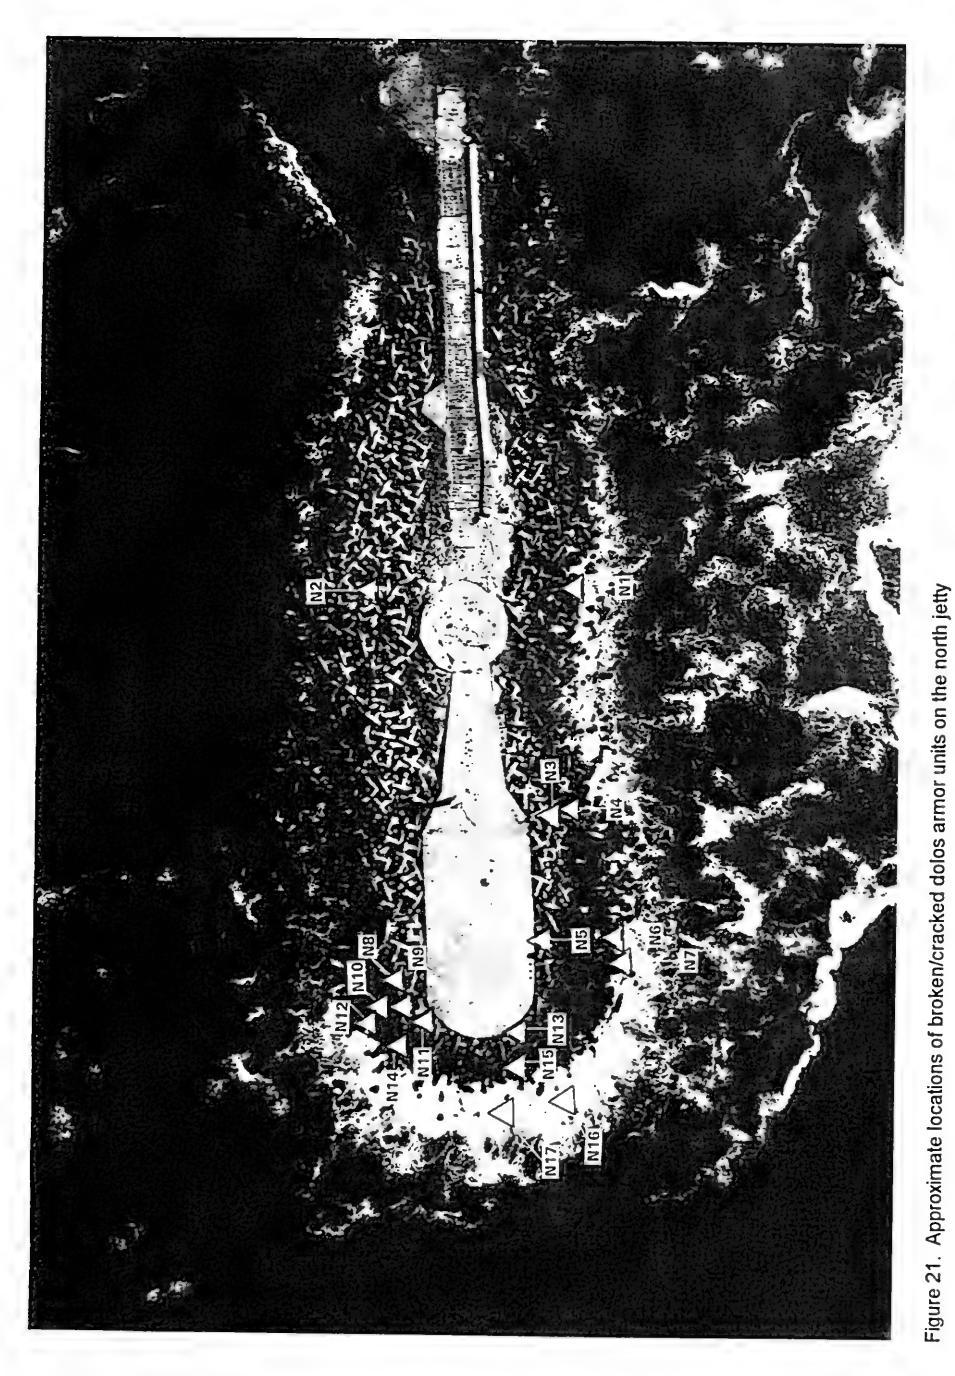
Approximate locations of the broken/cracked dolos armor units are shown in Figures 21 and 22, respectively, for the north and south jetties; and detailed data obtained during the broken armor unit inventory are shown in Table 4. Armor unit numbers identified in Figures 21 and 22 correspond to those listed in Table 4. As shown on the figures, broken units are concentrated along the seaward ends of the jetties. Eighty-eight percent of the broken units on the north jetty and seventy-one percent of those on the south jetty are located around the monolithic structures at the jetty heads. In addition, more broken dolosse were observed on the south sides of the structures than on the north. If the approximate center lines of the jetties are projected seaward along the axes of the structures, 59 percent of the broken units on the north jetty and 65 percent of those on the south jetty are located on the south regard to distance downslope from the jetty caps, most the broken dolosse appear to be located in the active wave zone. Detailed data obtained during the broken armor unit survey will allow for an accurate indication of new breaks when the structure is revisited at some point in the future.

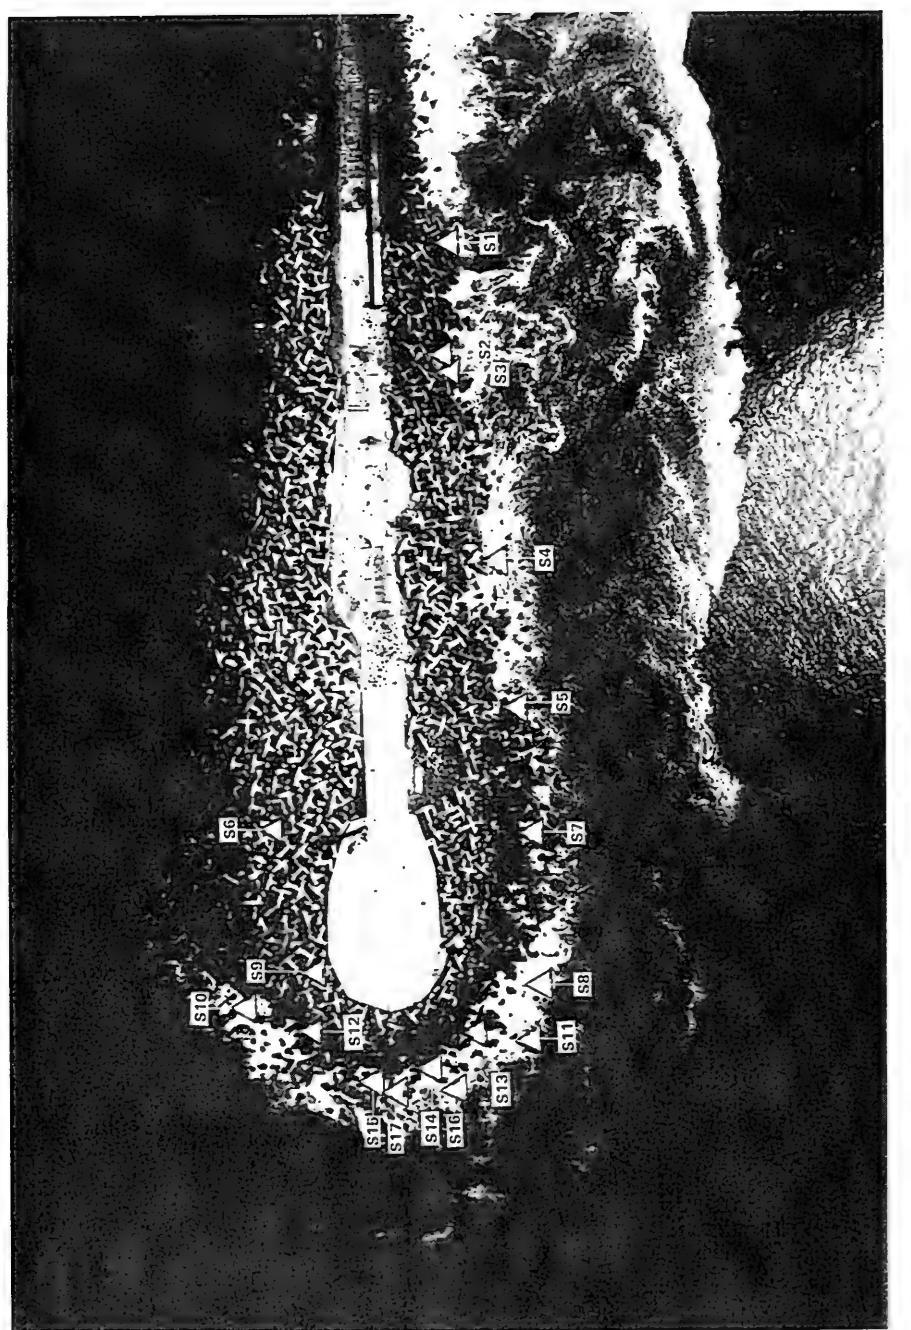
Figure 22. Approximate locations of broken/cracked dolos armor units on the south jetty
